Delivery Order 9 Enhanced Preliminary Assessment

FORT DEVENS, MASSACHUSETTS

April 1992

1. AGENCY USE ONLY (Leave blank)		2. REPORT DATE 30 April 1992	3. REPORT TYPE AND DATES COVERED Final December 1991 - April 1992	
4. TITLE AND SUBTITLE Enhanced Preliminary Assessment Fort Devens, Massachusetts			5. FUNDING NUMBERS Contract No. DAAA15-90-D-0009 Delivery Order 9

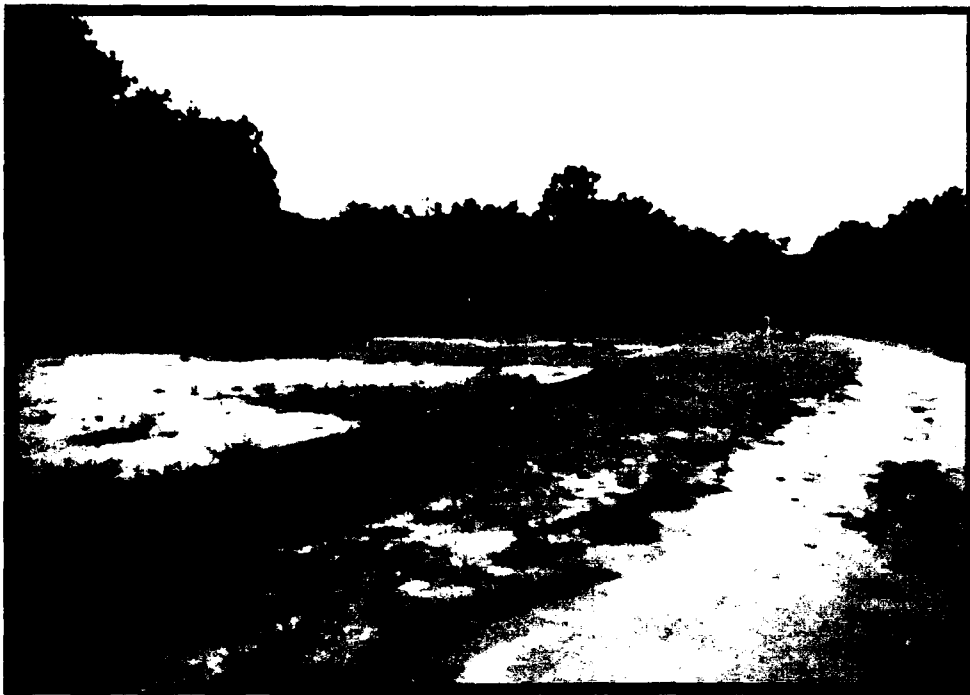
11. AREE 20 - TYPICAL RAPID INFILTRATION BASIN
